ROVVER

Funny name for a Closed Circuit Video Inspection Unit, but that's what [EverestVIT](#) calls it.

PICTURES OF SOME OF THE PROBLEMS ROVVER FINDS

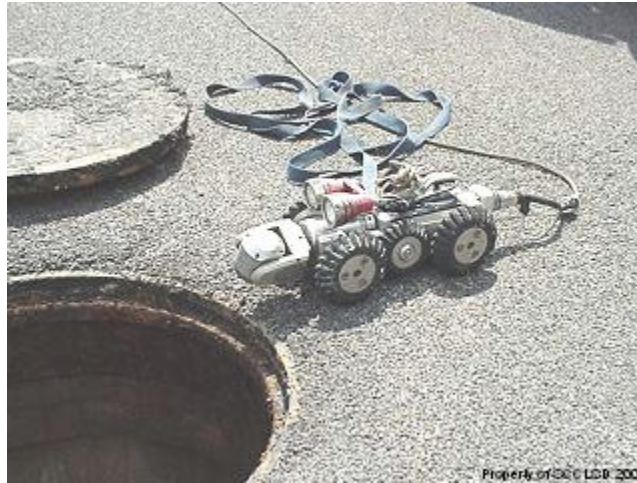
Actually, that is the name of the crawler part. Pictured above is a Pan and Tilt Camera Head mounted on a Rovver 600 Crawler.

The rest of the package includes a 600 foot motorized cable reel, the control unit with remote pendant, auxiliary lights, a VHS video recorder, a couple of monitors, a power inverter, and tool box.

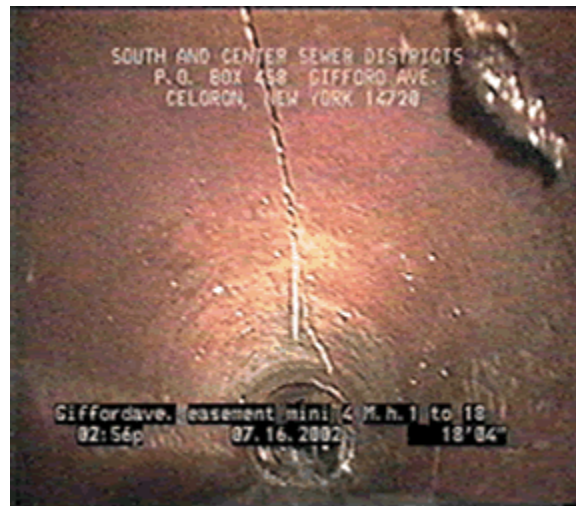
Broken Pipe

Some of the pipe we have was installed in the late 20's making it over 70 years old. Cracks and Breaks can be a problem.

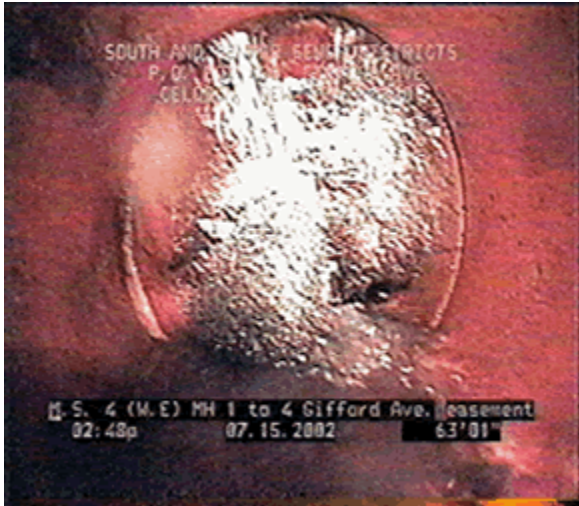
Grease

Yes, that *is* what grease does in the sewer, so try and empty your bacon grease (and all other grease) in a can and throw it away.

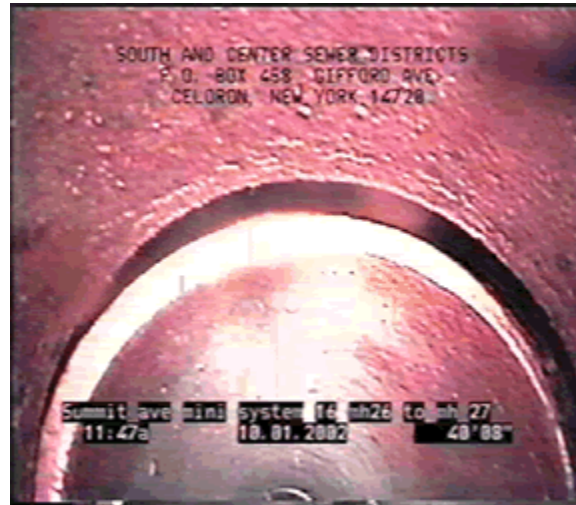
Obstruction

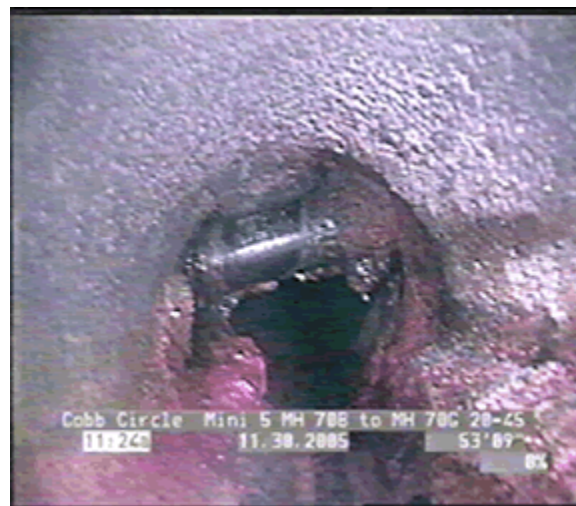
Protruding Tap

Yes, that is a natural gas line punched through the sewer pipe. That's why New York State has now made it mandatory that everyone call [UFPO\(Dig Safely NY\)](#) every time they work underground. 1-800-962-7962.
